## **REPAIRS AND ADDITIONS TO REMOVABLE PARTIAL DENTURES**

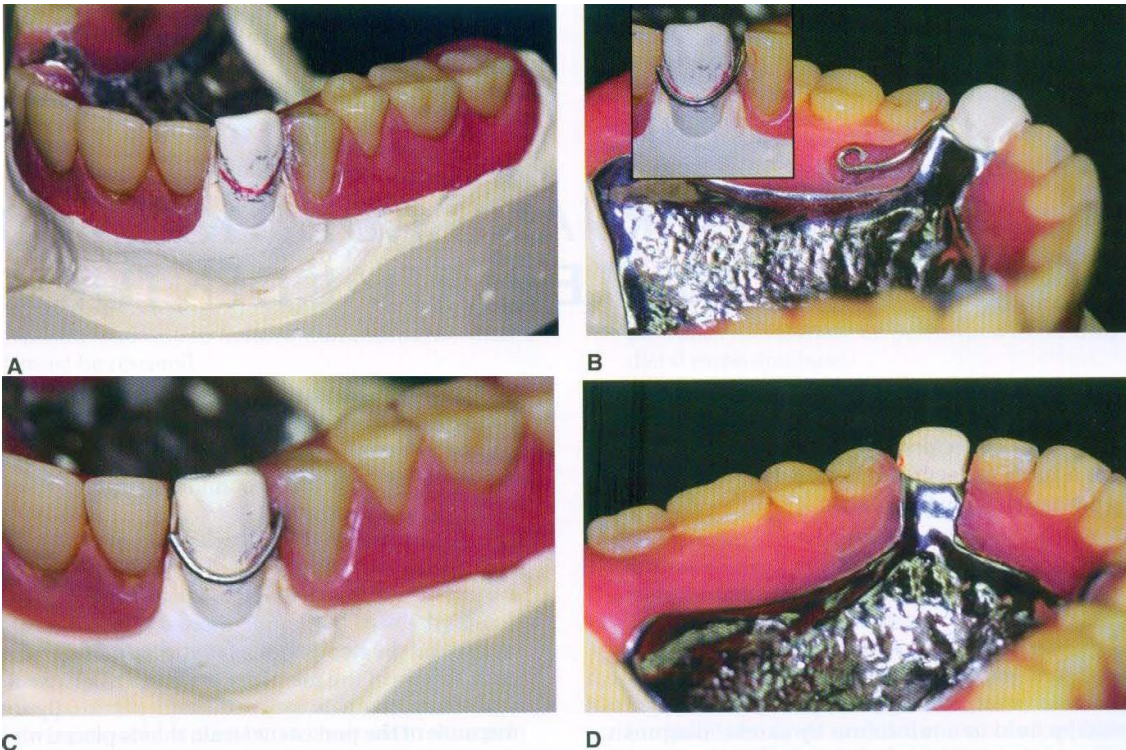
2- Breakage may occur as a result of structural failure of the clasp arm itself. A cast clasp arm that is not properly formed or is subject to careless finishing and polishing will eventually break at its weakest point. This can be prevented by providing the appropriate taper to flexible retentive clasp arms and uniform bulk to all rigid nonretentive clasp arms. Wrought-wire clasp arms may eventually fail because of repeated flexure at the region where it exits from the resin base, see (Figure-1- ).

**(Figure-1- )** {Fractured direct retainer on canine abutment. Reason for breakage is likely the long- term repeated flexure from movement associated with this 8 years old distal extension prosthesis. Denture must be evaluated for prospective serviceability if retainer arm is repaired. Often, patient will best be served by replacing denture with new restoration. **A:** cast produced from irreversible hydrocolloid impression, height of contour is shown in pencil with red line illustrating to lab the location of repair wire (18 gauge).**B:** Clasp adapted to designated line on canine and fitted into resin trough distal to canine and palatal to first and second premolars. Note the curvature placed at the end of the wire to prevent movement within polymerized resin. **C:** Finished and polished wire repair from the buccal and **D:** Palatal view}.

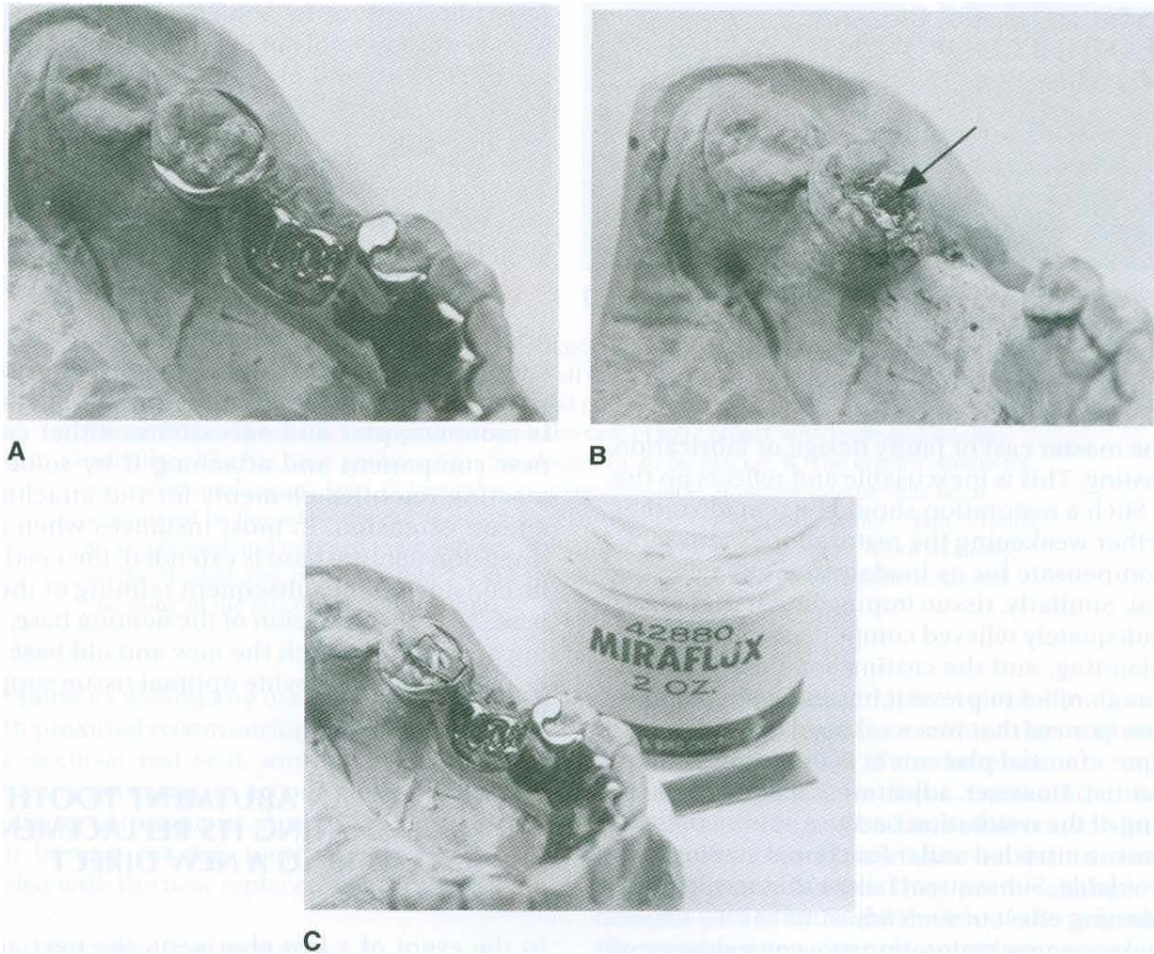
Breakage of an occlusal rest almost always occurs where it crosses the marginal ridge. Improperly prepared occlusal rest seats are the usual cause of such weakness; an occlusal rest that crosses a marginal ridge that was not lowered sufficiently during mouth preparations either is made too thin or is thinned by adjustment in the mouth to prevent occlusal interference. Failure of an occlusal rest rarely results from a structural defect in the metal and rarely if ever is caused by accidental distortion. Therefore the blame for such failure must often be assumed by the dentist for not having provided sufficient space for the rest during mouth preparations.

**(Figure-2- )** { **A:** Occlusal rest on molar fractured and was lost. Adequacy of present rest seat must be evaluated as well as interocclusal space available for rest before repair procedure is undertaken. **B:** Denture is removed from cast, and platinum foil (arrow) is adapted to rest seat area and over marginal ridge of abutment. **C:** Flux is applied sparingly to areas involved and solder is placed in position }.

Soldering may repair broken occlusal rests. In preparation for the repair, it may be necessary to alter the rest seat of the broken rest or to relieve occlusal interferences. With the removable partial denture in its terminal position, an impression is made in irreversible hydrocolloid and then removed, with the removable partial denture remaining in the impression. The dental stone is poured into the impression and allowed to set. The removable partial denture is then removed from the cast, and platinum foil is

adapted to the rest seat and the marginal ridge and overlaps the guiding plane. The removable partial denture is returned to the cast and, with a fluoride flux, gold solder is electrically fused to the platinum foil and minor connector in sufficient bulk to form an occlusal rest, see (Figure-2- ).

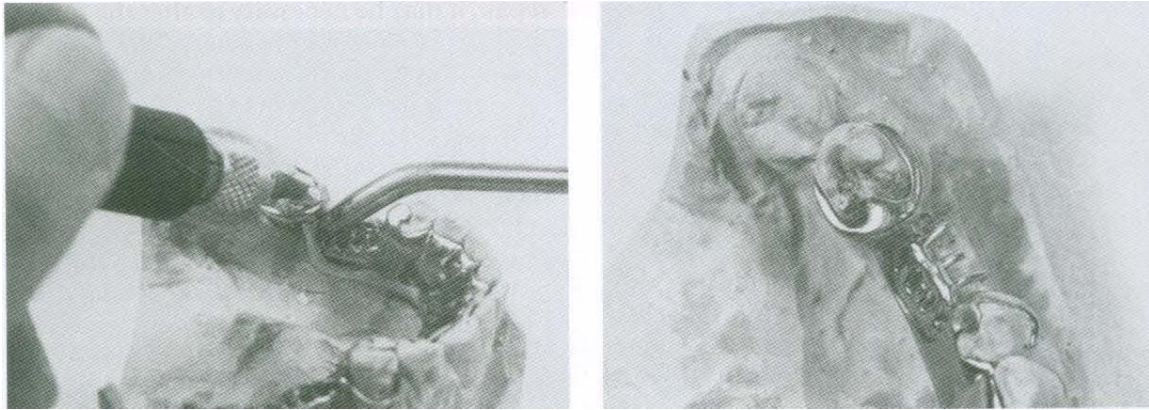
(**Figure-3-** ) {**A:** Electrical soldering is used to repair rest. **B:** Rest is shaped to conform to rest seat outline. Framework is tried in patient's mouth for any necessary adjustment and rest is polished}.

An alternative solder to use is an industrial brazing alloy, which is higher fusing but responds excellently to electric soldering and does not tarnish, see (Figure-3- ).

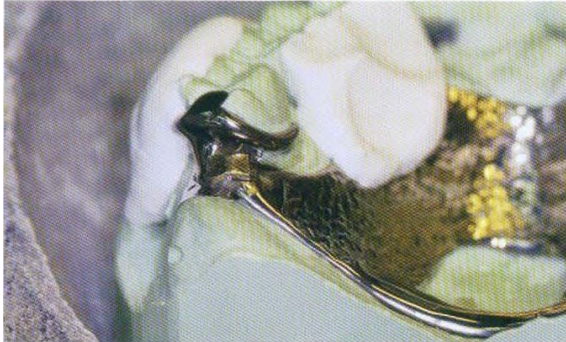
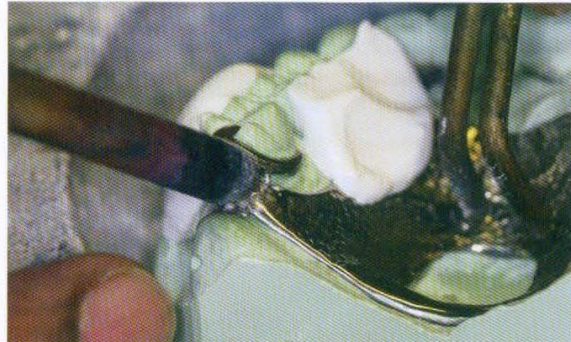
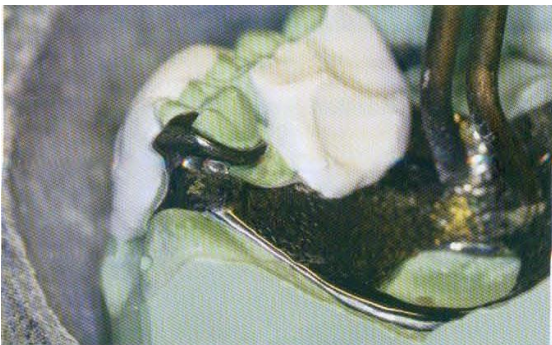
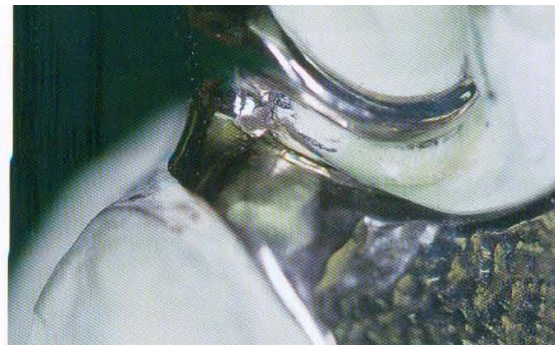
**(Figure-4- )**{ **A:** Maxillary juncture between major and minor connector at the distal of most posterior molar has fractured. Thin platinum foil has been adapted to the cast beneath the fracture, the clasp assembly has been stabilized on the cast with fast-set plaster, the remainder of the prosthesis has been positioned on the cast in full contact with teeth and tissues, and the solder has been positioned for the electric tip to be replaced. **B:** The electric soldering tip and ground are in place **C:** Immediately following solder flow, the fracture has been eliminated by the solder connecting the tow segments **D:** The polished solder repair is ready to be cleaned and returned to the patient. The patient is told that the repair is not as strong as the original and while it is difficult to know how long it could serve the patient, careful handling of the prosthesis is mandatory }.

weakening the restoration by attempting to compensate for its inadequacies by relieving the metal. Similarly, tissue impingement that arises from inadequately relieved components results from faulty planning, and the casting should be remade with enough relief to prevent impingement. Failure of any component that was weakened by adjustment at the time of initial placement is the responsibility of the dentist. Commonly, repeated adjustment to a major or minor connector results in a loss of rigidity to the point that the connector can no longer function effectively. In such situations, either a new restoration must be made or that part must be replaced by casting a new section and then reassembling the denture by soldering. The cost and probable success must then be weighed against the cost of a new restoration. Generally the new restoration is advisable, see (Figure-4- ).

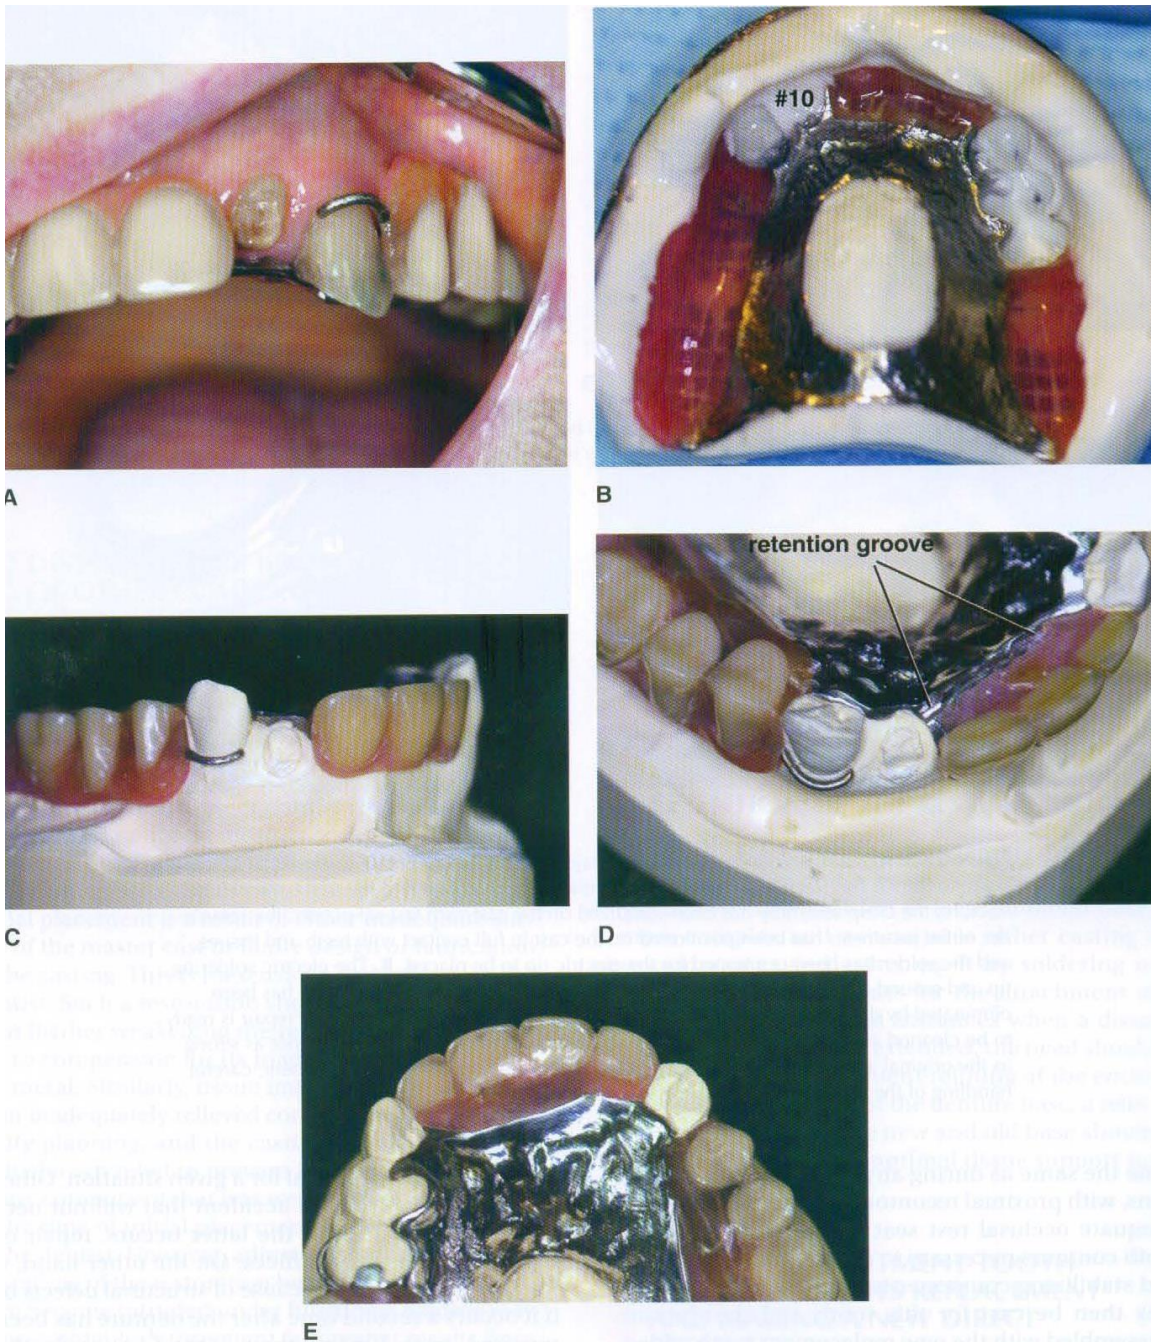
**(Figure-5- )**{This patient presented with an asymptomatic fractured lateral incisor. **A:** Clinical presentation of fractured tooth and prosthesis. Evaluation of the prosthesis revealed it to be adequately fitting, stable and retentive. **B:** Pick-up impression of prosthesis. **C:** Cast formed from pick-up impression showing a fully seated prosthesis. **D:** Preparation of the prosthesis included mechanical means for retention (which was provided by creating a recess in the resin adjacent to the missing tooth), and creating a trough at the external finishing line to

repair an area of marginal breakdown. **E:** Finished repair that will be taken to the mouth and checked for occlusal clearance lingual to the maxillary anterior teeth }.

Additions to a removable partial denture are usually simply made when the bases are made of resin, see (Figure-5- ). The addition of teeth to metal bases is more complex and necessitates either casting a new component and attaching it by soldering or creating retentive elements for the attachment of a resin extension. In most instances when distal extension denture base is extended, the need should be considered for subsequent relining of the entire base. After the extension of the denture base, a relining procedure of both the new and old base should be carried out to provide optimal tissue support for the restoration.
